Smoke and Dye-Water Observation Summary

Western Run Pilot Project - Baltimore Maryland

Dye Test 54

INSPECTION REPORT

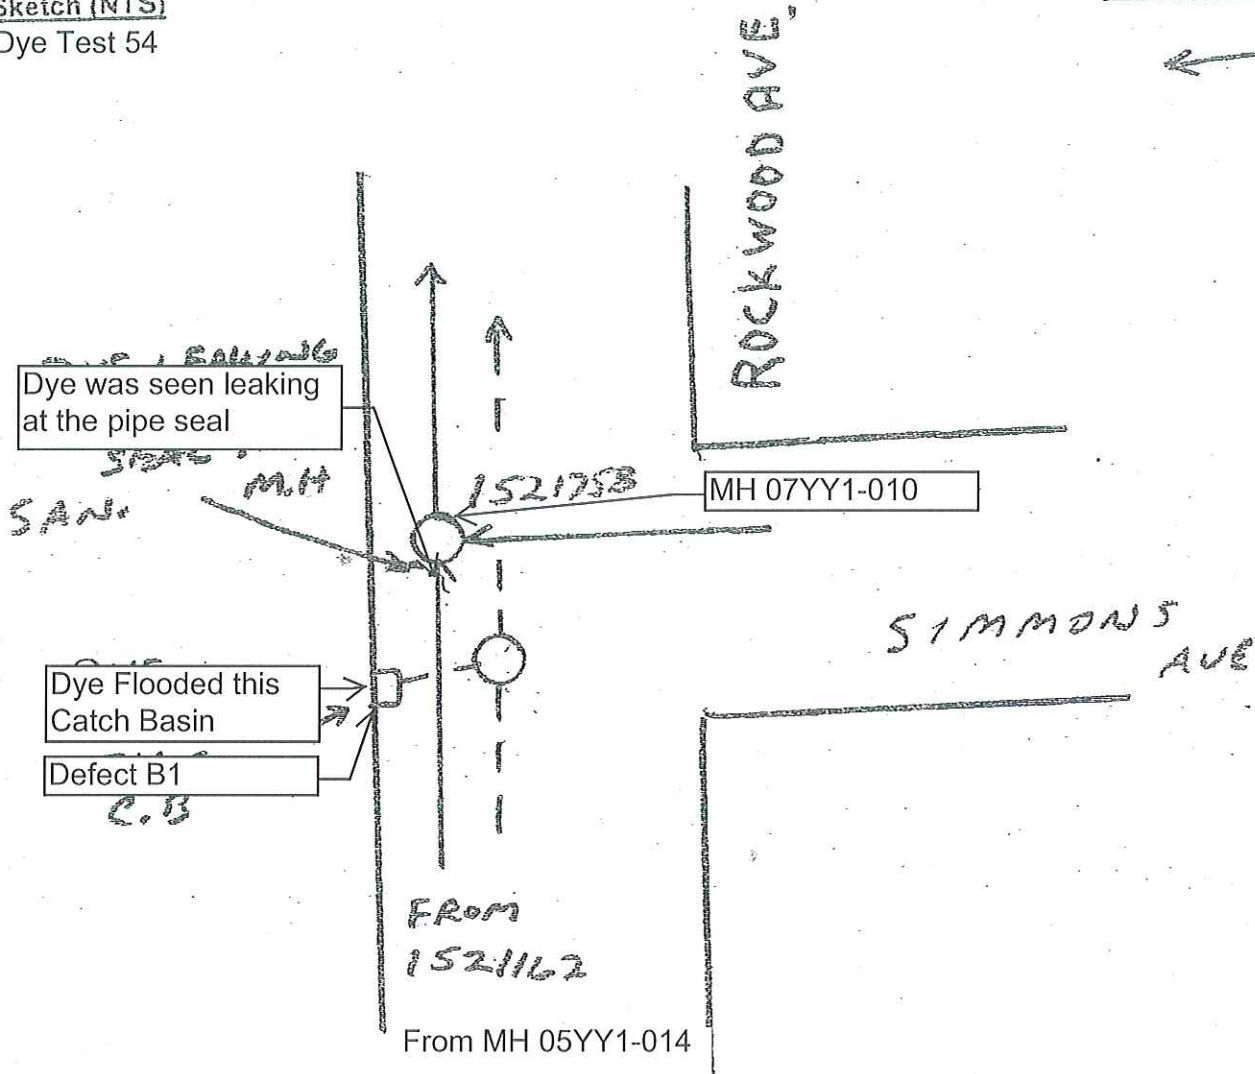
DESIGN CODES		SOURCE TYPE CODES			
1. POSITIVE	1. MAIN SEWER	5. DOWN SPOUT	9. STAIRWELL DRAI	13. STORM DRAIN	
2. NEGATIVE	2. SERVICE LINE	6. DWNSPT CONN.	10. FOUNDATION DRAIN	14. CATCH BASIN	
3. CANNOT TEST	3. TRANSITION JOIN	7. AREA DRAIN	11. BUILDING INTERIOR	15. STORM MH	
	4. CLEAN OUT	8. DRIVEWAY DRAIN	12. MH FRAME/SEAL	16. STORM DITCH	
Additional Comments: TUED IN M.H. 1521162. NO DYE SEEN COMING FROM IN THE PIPE.

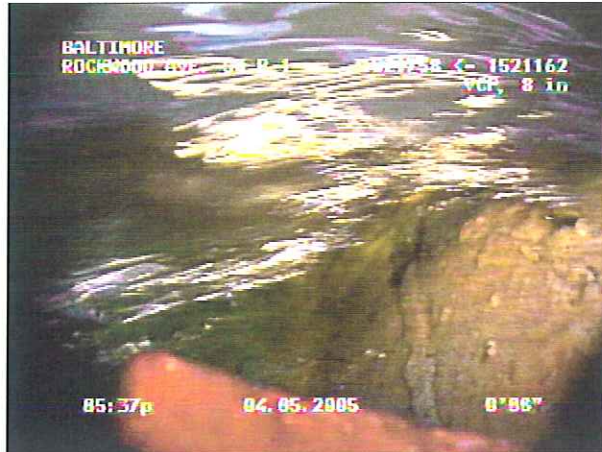
IMAGE: 44a, TAPE #: JAM 2, 00:41:53
2FT, inspection begins at downstream manhole, 1521758.
LEAKING FROM PIPE SEAL OF LINE FROM M.H. 1521162
